**Flood Control Project Maintenance
Levee Inspections**

Maintenance Issue Types Only, Levee Inspection Report By Mile - Fall 2018

Sacramento Maintenance Yard Willow Slough Bypass

Waterway	Bank	Unit Miles	Inspection Start/End	Inspector
Unit No. 01 Willow Slough Bypass or North Levee	Left	5.05	09/05/2018 09/05/2018	Zach Jojola

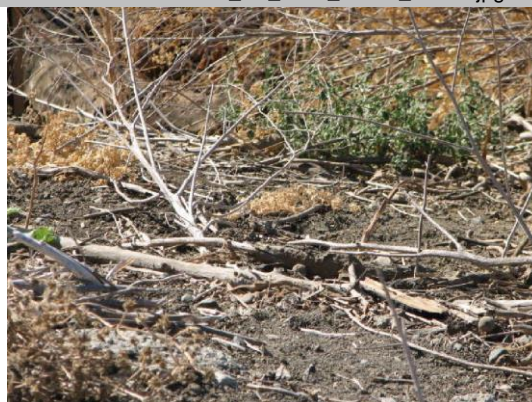
Photo 2 of 3 : UCIP_FA_2018_44903_22881.jpg

Waterside view- general view

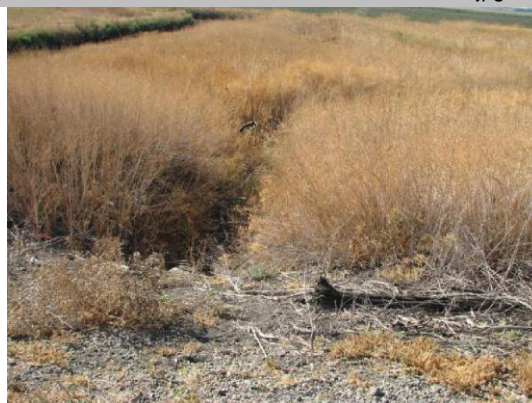
Photo 3 of 3 : UCIP_FA_2018_44903_22880.jpg

Waterside overview. Notice waterway.

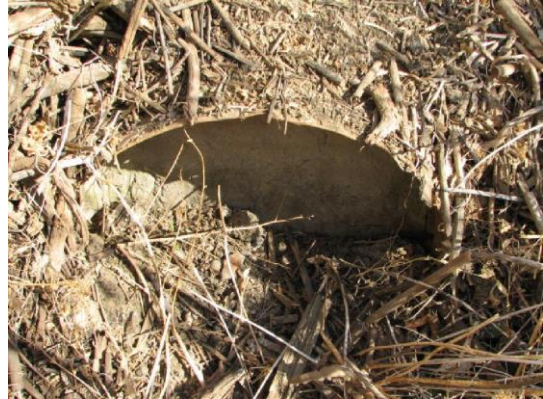
Photo 1 of 3 : UCIP_FA_2018_44904_22885.jpg

Comment Code					
Inspector Comment					
FS_ID:44904 DS_ID:17613 EP_NO: 10309 Repair Type: No Action Needed Crossing Status: Found UCIP Comments: 09/19/2012 Abandoned in place. CMP filled with concrete. (DWR UCIP - P. Amatya) FIELD_STRUCT_DESC: 30-inch steel drainage pipe through the levee, 16.5 feet below the crown. Flap gate is located on the waterside (WS) end. Manhole and grate are located on the landside (LS) toe. (30-inch pipe [HLM 0.01] authorized under Automatic Board Order (ABO) issued as Permit No. 10309, 1974 - City of Davis). [Additional Reference(s): DWR Levee Log, 1990. USACE Sacramento O&M Manual Unit 120, Willow Slough Channel Relocation and Levee Construction, February 1947, Drawing No. 50-4-2281 Sheet 4 (Station 270+70)] FS Date: 5/5/2015 8:02:49 AM

Waterside view- CMP grouted with concrete.

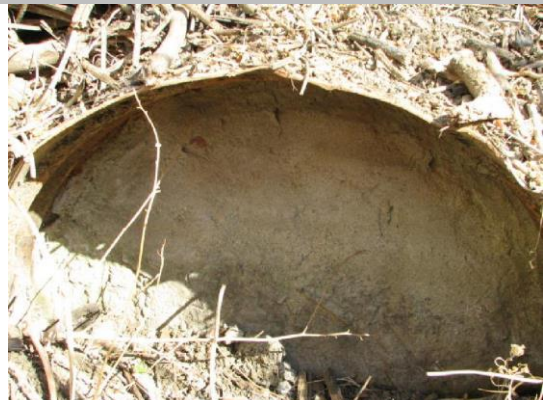
Photo 2 of 3 : UCIP_FA_2018_44904_22884.jpg

Waterside view- CMP grouted with concrete (closer view)

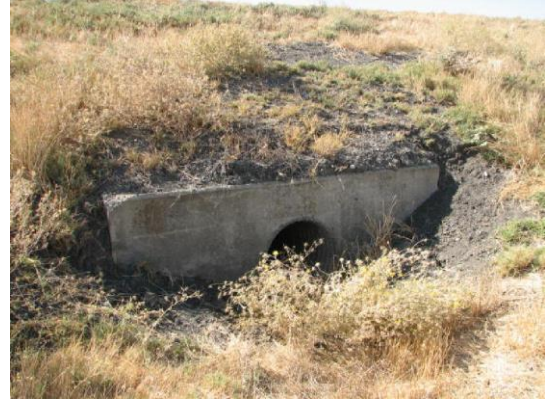
Photo 1 of 3 : UCIP_FA_2018_44907_22894.jpg

Comment Code						
Inspector Comment						
FS_ID:44907 DS_ID:17608 EP_NO: 10313 Repair Type: No Action Needed Crossing Status: Found UCIP Comments: 04/12/2017 LS - dump has it plugged, WS - ditch need to be established debris higher than water, inspected by JK, RF. (DWR Sacramento Yard - C. Lund) 09/19/2012 Pipe sits on concrete saddle on WS. (DWR UCIP - P. Amatya) FIELD_STRUCT_DESC: 24-inch corrugated metal drainage pipe through the levee, 13.5 feet below the crown. Flap gate is located on the waterside (WS) end. (24-inch pipe [HLM 0.79] authorized under Automatic Board Order (ABO) issued as Permit No. 10313, 1974 - Lear). [Additional Reference(s): DWR Levee Log, 1990. USACE Sacramento O&M Manual Unit 120, Willow Slough Channel Relocation and Levee Construction, February 1947, Drawing No. 50-4-2281 Sheet 2, 4 (Station 232+43)] FS Date: 5/5/2015 8:06:14 AM

Landside view- pipe and headwall

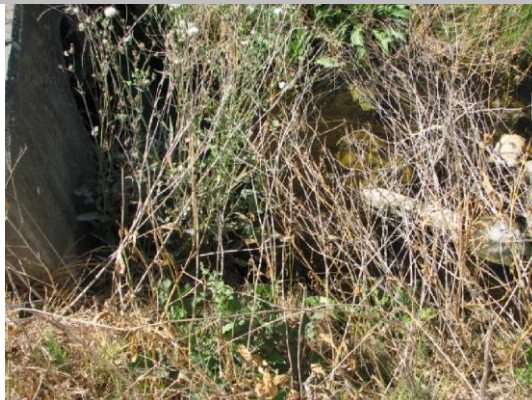
Photo 3 of 3 : UCIP_FA_2018_44942_22960.jpg

Landside view- vegetation around inlet.

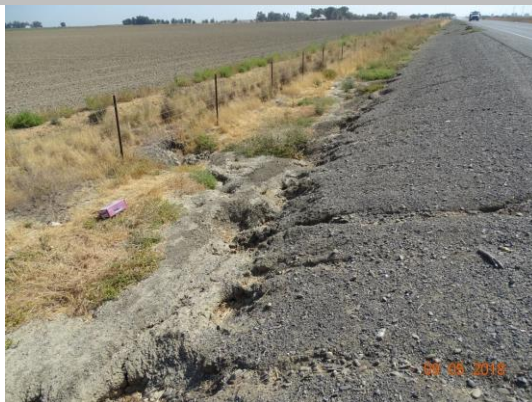
Photo 1 of 3 : FA_2018_ST0012_295_10_20180905_00005.jpg

LM Start	2.93	Rating **	M	Issue No.	10
LM End	3.00	Issue Type +	Ma	Location *	LS
Category	Earthen Levee			GPS Latitude/Longitude	
				Start	End
Item	Erosion / Bank Caving			38.590572 °	38.590653 °
				-121.719349 °	-121.720714 °
DWR ID	DWR_ST0012_01_s_ 2015_10				
Comment Code					
E1 : Note and monitor erosion site.					
Inspector Comment					
Appears to be runoff on the landside slope. Possibly an abandoned pipeline that is caving in.

Updated view of the erosion on the landside slope. Fall 2018.

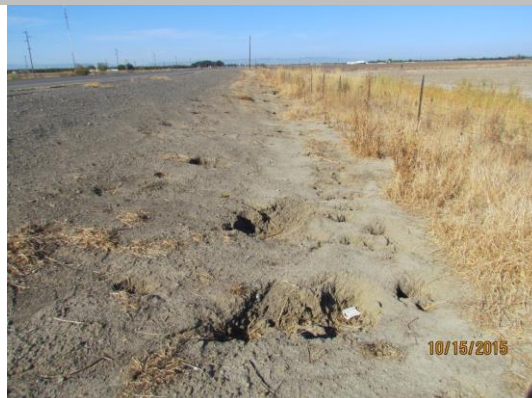
Photo 3 of 3 : FA_2018_ST0012_295_10_20180904_00002.jpg

View of the erosion on the landward side of the levee looking upstream. Fall 2015.

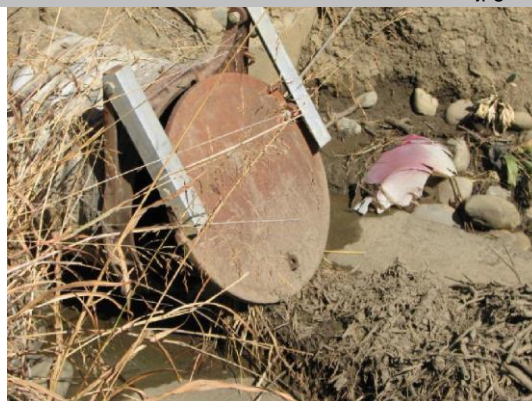
Photo 3 of 3 : UCIP_FA_2018_44947_22986.jpg

Waterside view- pipe, flap gate and debris. The pipe sits on concrete saddle.

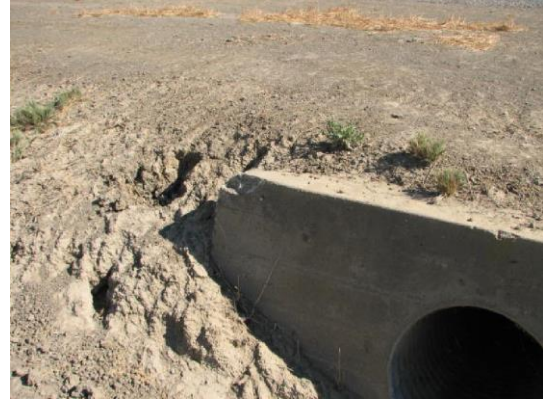
Photo 3 of 3 : UCIP_FA_2018_13725_22468.jpg

Landside view- concrete headwall corner chipped off

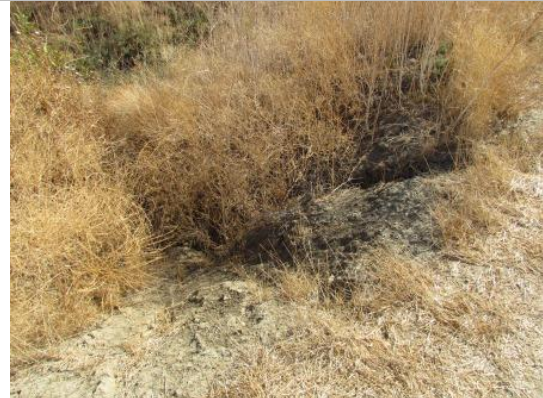
Photo 1 of 1 : FA_2018_ST0012_296_23_20180904_00026.jpg

View of an erosion site around UCIP pipe FSID 13725 on waterward side of the levee. Fall 2016.

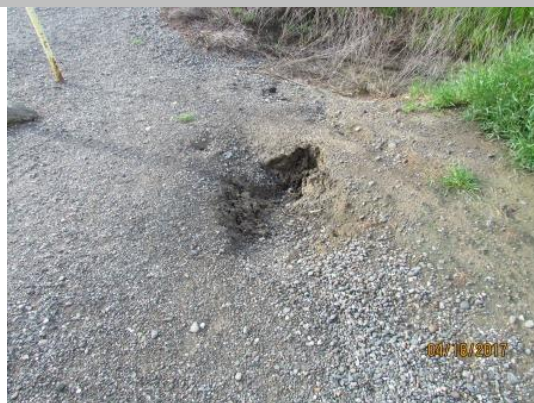
Photo 1 of 1 : FA_2018_ST0012_296_29_20180904_00028.jpg

View of tire damage on landside levee slope. Spring 2017.

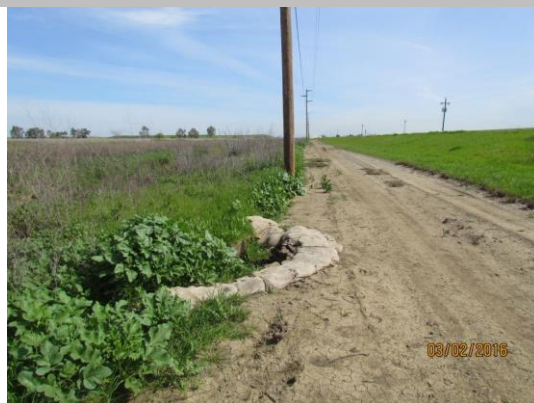
Photo 2 of 2 : FA_2018_ST0012_296_10_20180904_00011.jpg

View of the erosion on the toe road looking downstream. Spring 2016.

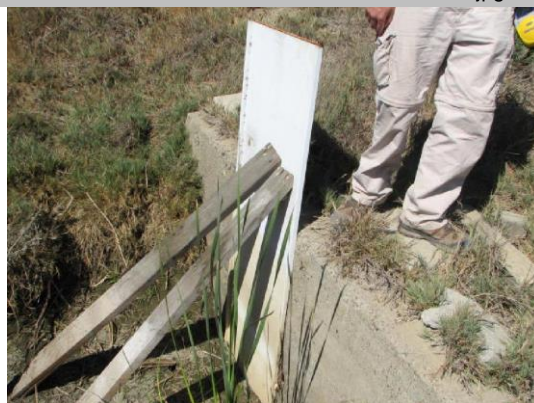
Photo 1 of 3 : UCIP_FA_2018_45291_22479.jpg

Landside view- concrete headwall and pipe (temporarily closed used wooden planks).

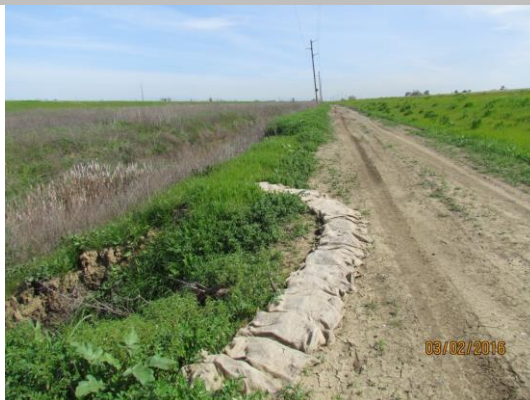
Photo 1 of 1 : FA_2018_ST0012_296_18_20180904_00022.jpg

View of the erosion on the waterward side looking downstream. Spring 2016.

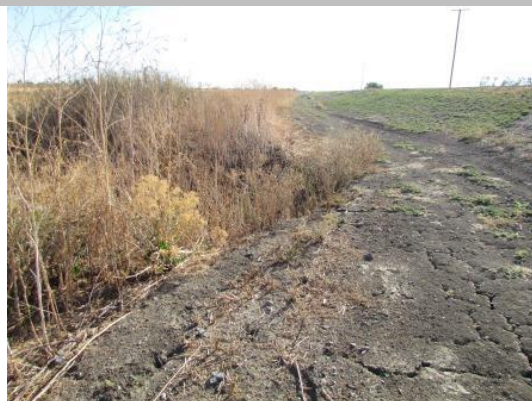
Photo 2 of 3 : FA_2018_ST0012_296_11_20180904_00013.jpg

Perspective view of the site. Fall 2016.

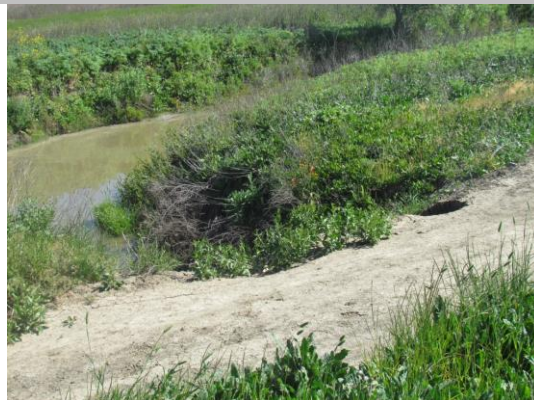
Photo 2 of 3 : FA_2018_ST0012_296_15_20180904_00019.jpg

View of the erosion on the edge of the channel on the waterward side of the levee. Spring 2015.

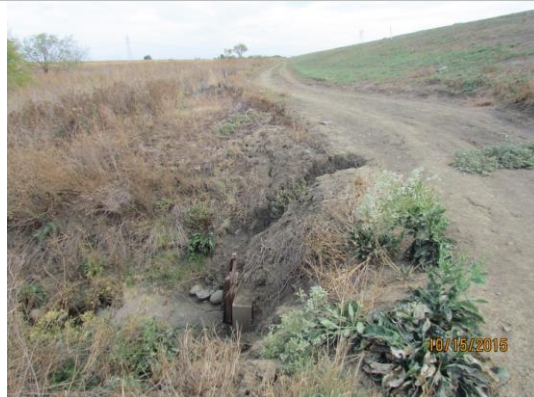
Photo 3 of 3 : FA_2018_ST0012_296_15_20180904_00020.jpg

View of the erosion at the edge of the channel on the waterward side of the levee looking downstream. Fall 2015.
